## WELDING INSPECTION REPORT

Resident Engineer: Pursell, Gary **Report No:** WIR-011740 Address: 333 Burma Road **Date Inspected:** 15-Jan-2010

**OSM Arrival Time:** 1900 **Project Name:** SAS Superstructure **OSM Departure Time:** 700 **Prime Contractor:** American Bridge/Fluor Enterprises, a JV

**Bridge No:** 34-0006 **Component:** OBG

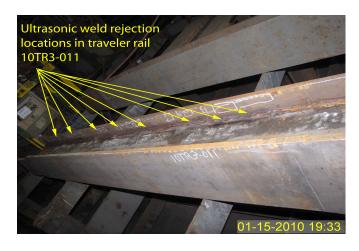
Traveler rail 10TR3-011 has approximately 30 locations where ZPMC ultrasonic Inspectors have marked ultrasonic rejections, and ZPMC does not appear to have started repairs of these locations.

Traveler rail 10TR3-038 has fifteen locations where ZPMC appears to have used the air carbon arc process to remove portions of the web plate lower weld (no number identified) and each of these locations appear to have been ground to a bright metal condition. This QA Inspector measured the depth of each of these fifteen locations and observed that the average depth is approximately 8mm and the deepest gouged area is approximately 11mm. The nominal thickness of this web appears to be 15mm and the two locations which have 11 mm grind depth will require a critical weld repair to be issued and approved prior to welding (no number identified). Note: no ZPMC QC or ABF representatives were observed in this bay.

Traveler rail 10TR3-022 has a bow over the 10 meter length and this QA Inspector will attempt to measure the extent of this bow at a later time. This QA Inspector observed ZPMC has a notebook sitting on one of the traveler rails and this notebook appears to contain heat straightening documentation, but no personnel appear to be performing heat straightening during this shift. See the photographs below for additional information.
